TREATMENT REPORT

REPORT OF ON-SITE RESTORATION TREATMENT MICARTA MURAL OF EAST COAST

(Documentation and Treatment carried out between February 16th and April 7th 2017)

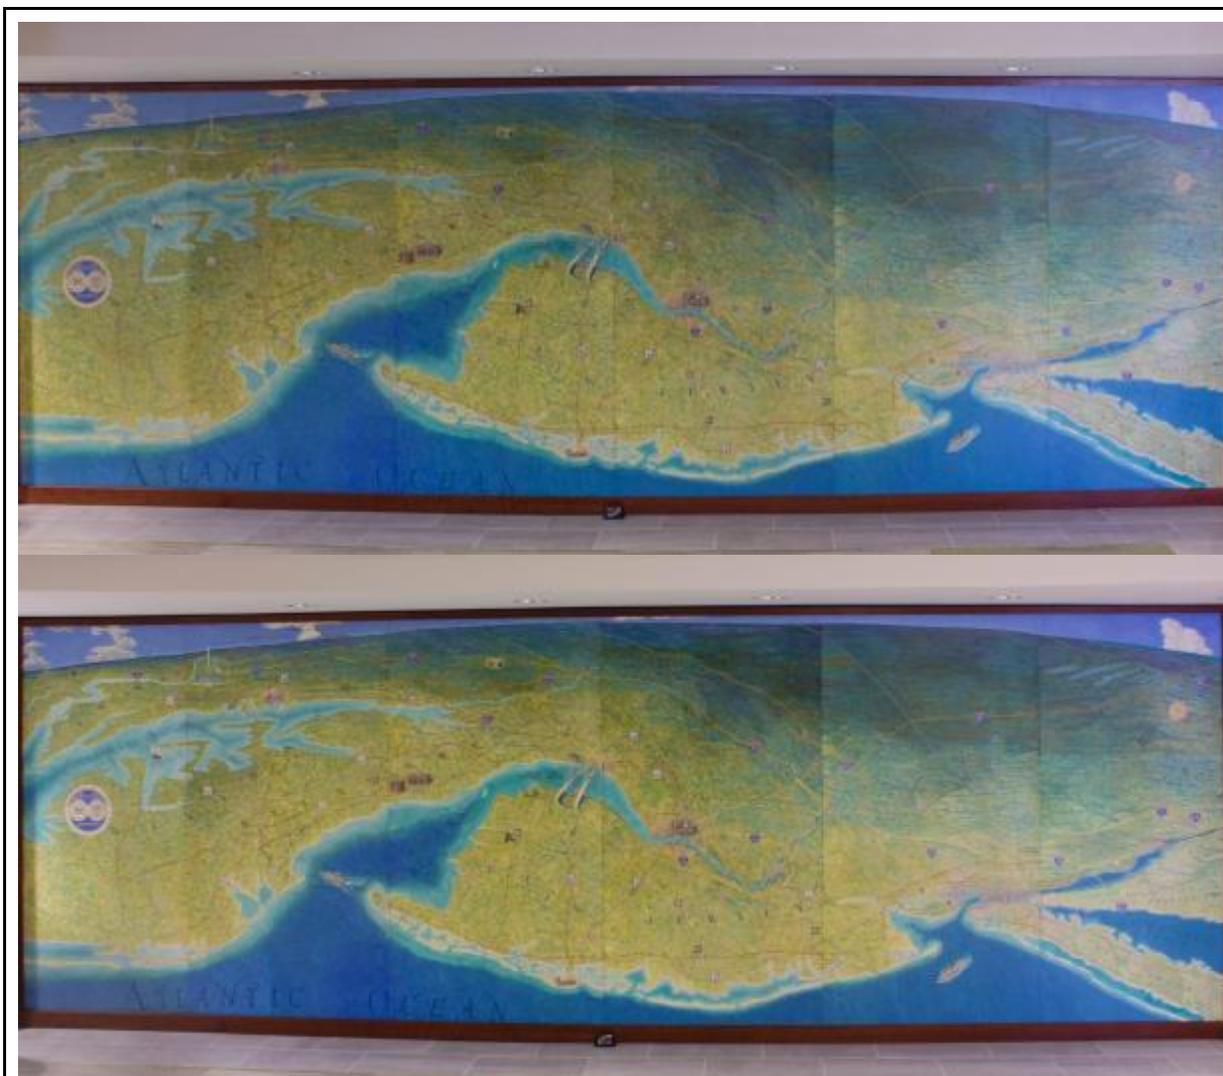
Figure 1. Before and after images of the mural taken with a Canon EOS Rebel T2i and adjusted with Lightroom Software to correct for differences in ambient lighting.

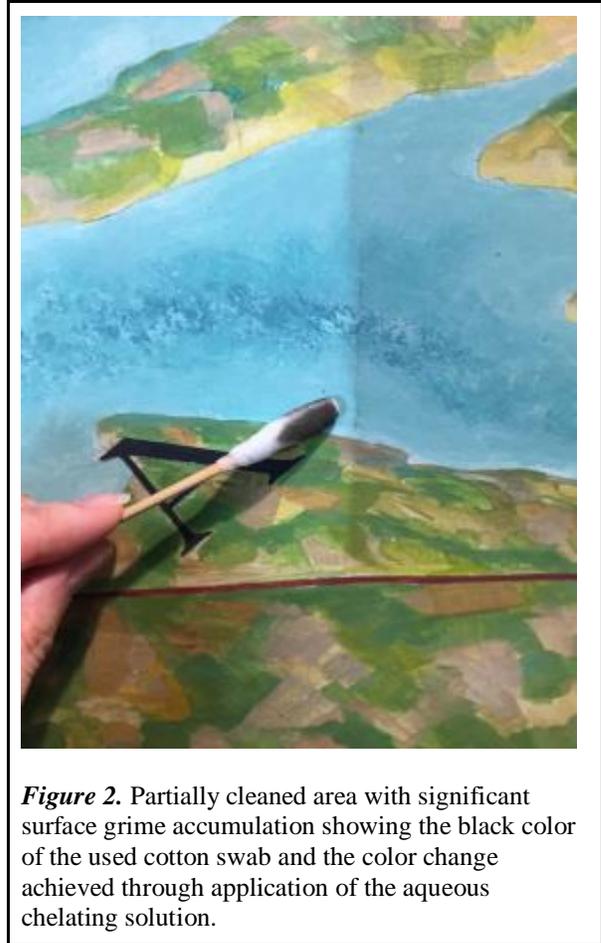
Figure 2. Partially cleaned area with significant surface grime accumulation showing the black color of the used cotton swab and the color change achieved through application of the aqueous chelating solution.

- ❖ Hand-made cotton swabs saturated in the aqueous chelating solution (enough to wet the surface without generating drips) were the primary tool used to reduce surface grime. The first swab passed over a given area appeared black with grime removed from the surface. This demonstrated that the chelator was immediately effective at separating the imbibed dirt from the aged surface of the synthetic varnish. After subsequent passes with the moistened swabs, the color of the used swabs slowly changed from black to pale gray. Consultation with deGhetaldi established that this reduced level of grime was acceptable, and the final rinse of the area with distilled water on cotton swabs would remove additional grime. In the areas of the mural that possessed a substantial layer of grime, cleaning typically required between 5 and 7 passes with the chelating solution; an additional 3 passes with distilled water was then needed in order to effectively clear the surface of any remaining potential residues. In areas that contained less grime, 3 to 4 passes with the chelating solution and 1 pass with water was found to be sufficient.

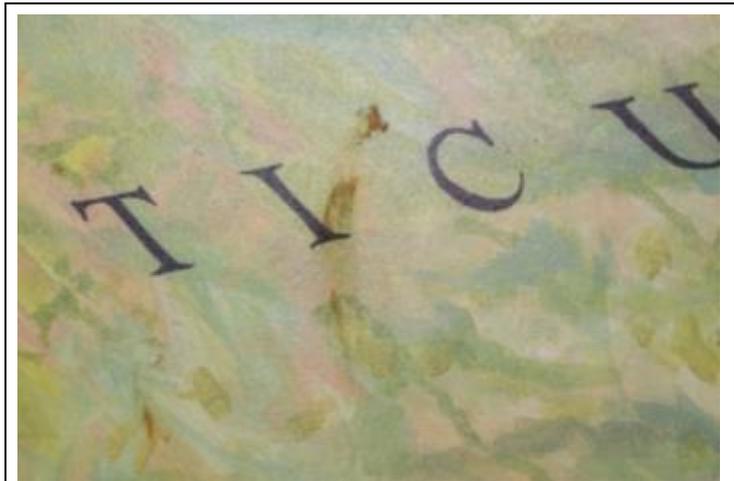
❖ In addition to a higher concentration of grime, a distinctly unique accretion appearing reddish-brown in color was found scattered on the bottom half of the mural. This substance adhered to the varnish surface and had a three-dimensional appearance (raised “blobs” measured as much as a ½ centimeter above the varnish layer). This particular accretion crumbled under applied pressure and was easily removed after the introduction of chelating solution. The chemical identity of this accretion was not determined.

Figure 3. Detail of a crumbly, reddish-brown accretion over Connecticut as seen prior to cleaning.

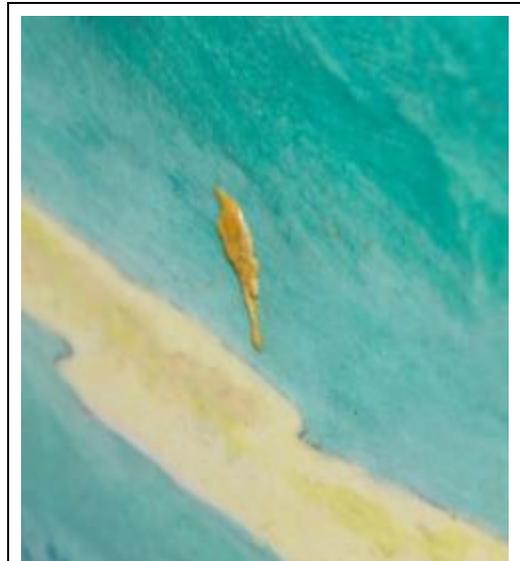
Figure 5. Detail near Long Island showing a raised reddish-brown accretion as seen prior to cleaning.

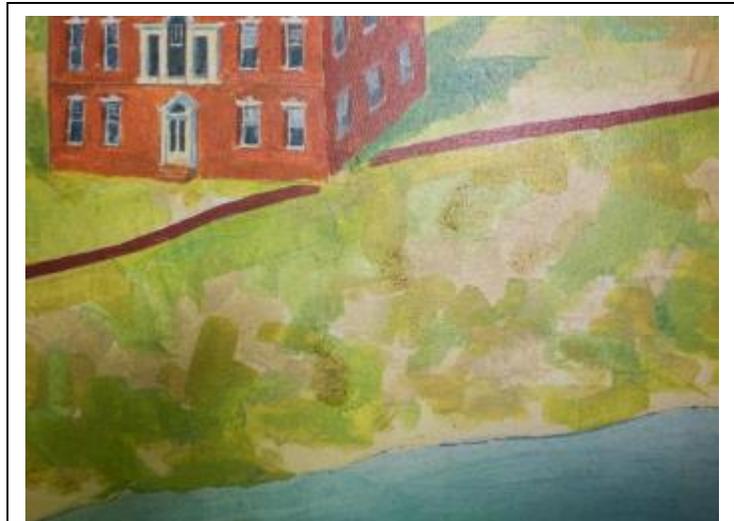
Figure 4. Detail of the mural representing Dover where a reddish-brown accretion in the shape of four finger prints was visible prior to cleaning. The finger prints are indicated with circles.

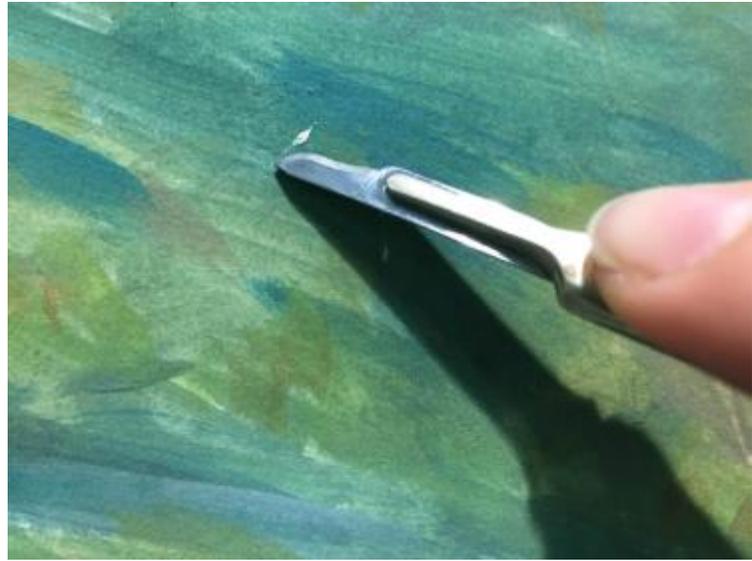
- ❖ In addition to surface grime and reddish-brown accretions, white-colored paint specks were present along the top of the mural. These dried paint deposits were on top of the varnish layer and also possessed a three-dimensional appearance. Some specks could be removed by applying pressure with a fingernail. Other specks necessitated the use of scalpels to carefully carve the paint down to the surface of the varnish. It is assumed that the paint specks were produced during the painting of a ceiling or nearby wall that was in proximity to the mural during/after its installation or reinstallation. All of the specks were effectively removed and none resulted in losses or damage to the varnish layer.

Figure 6. Detail of a paint speck on the surface of varnish being carefully removed with a scalpel during cleaning.

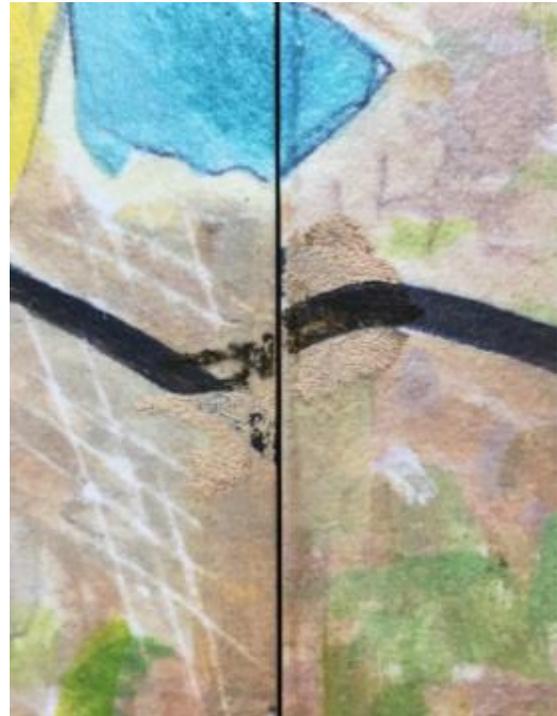
Figure 7. Detail of the overpaint spanning Long Island on Panels 5 and 6. This image shows the area after cleaning and before being toned with PVA paints.

- ❖ Paint that is applied over the final varnish layer (referred to here as overpaint) was found in four locations along a seam between two panels. These traces of overpaint may have been applied by Proctor himself and therefore were treated as original to the mural. These passages could have been done to correct slight misalignment in areas of the composition or to address damage incurred before or during the mural's initial installation. The Delaware River and Bay Authority may have some record of hiring Proctor to make these changes after the mural's installation. For this reason, the overpaint was avoided in cleaning in order to preserve it. Any losses sustained to the overpaint were toned with PVA paints. The four areas of preserved overpaint span the joins between Panels 3, 4, 5, and 6. Between Panels 3 and 4, overpaint is present at the horizon line and appears purple (see Figure 8). Another area of overpaint along the join of Panels 3 and 4 can be found along the west shoreline of the New Jersey peninsula and appears greyish-brown. Between Panels 5 and 6, there are two more areas of overpaint. The first (as noted on Panels 3 and 4) spans the horizon line and appears purple. The second area of overpaint is located along the west shoreline of Long Island and covers a section of road. It appears pale peach in the area representing land and black in the area representing road (see Figure 7). **These areas should be noted for future attempts at cleaning and conservation, because the original overpaint is highly water soluble and susceptible to being removed.**

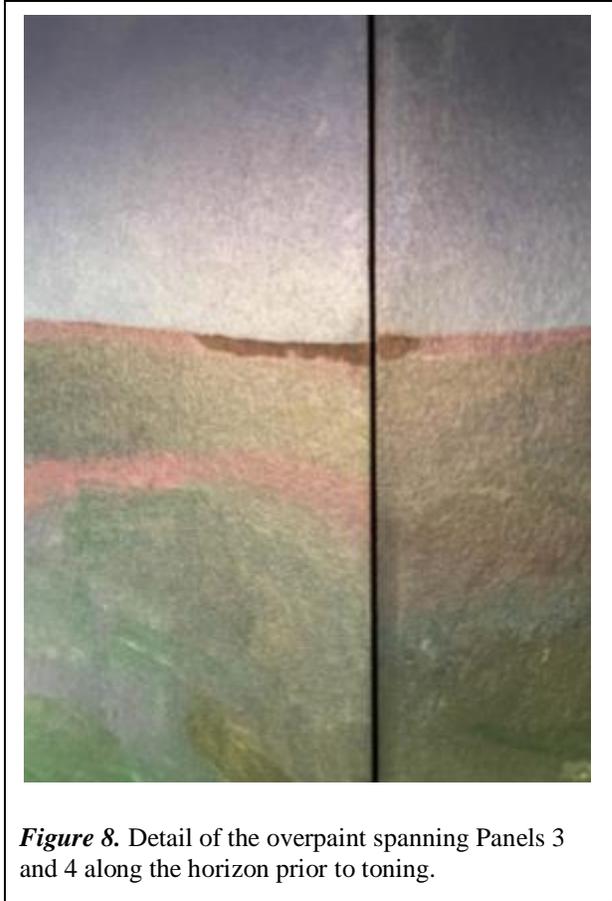
Figure 8. Detail of the overpaint spanning Panels 3 and 4 along the horizon prior to toning.

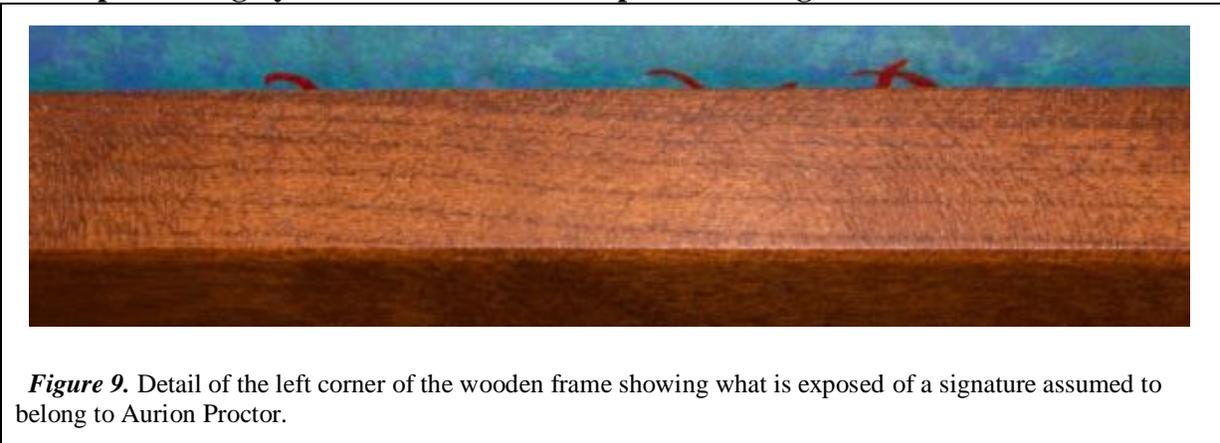
Figure 9. Detail of the left corner of the wooden frame showing what is exposed of a signature assumed to belong to Aurion Proctor.

- ❖ Unfortunately, no new surprises left by Proctor, such as houses in the hills or figures behind tiny windows, were found during the cleaning process. The only new development of note is the covering of what we assume is Proctor's signature, done in red paint in the lower left corner, by the frame. **Not only does this indicate that an authenticating area of original material is obstructed from view, but it suggests that at least an inch of painted area along the bottom of the panel could not be cleaned during our treatment.** Perhaps a future initiative could involve removing the wooden frame around the sides to allow for a full cleaning. Potential consequences of leaving the mural and especially the region behind the frame to be cleaned at an unspecified future date includes unequal degradation of the exposed and unexposed areas. Light damage or the embedding of dirt into the surface of the varnish layer could cause future discrepancies in color.

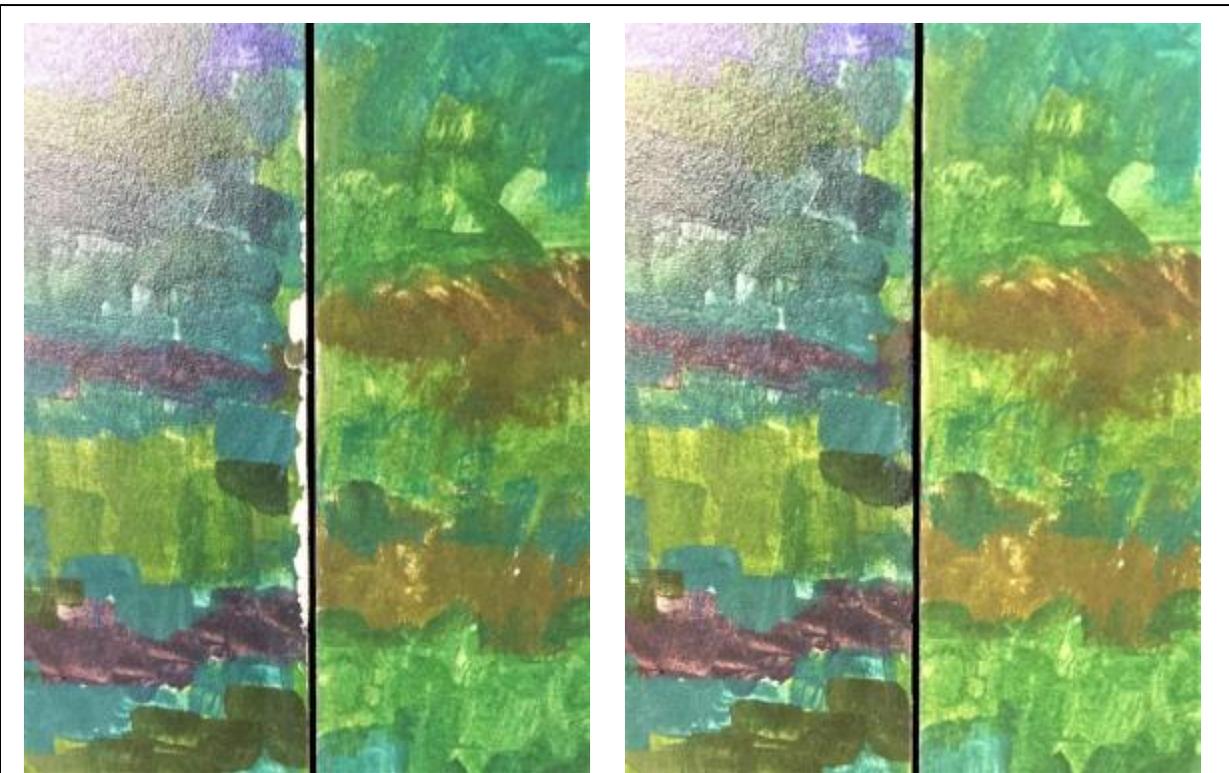
- ❖ Losses that required filling were located primarily along the edges of the panels. It can be assumed that this damage occurred during the installation, deinstallation, or reinstallation process. All of these losses were successfully filled and inpainted; however, one loss in the lower left corner appears to have been caused by a nail or screw penetrating the panel from the verso resulting in the formation of a circular, raised paint "flake" that partially exposes the underlying paper and plywood substrate. After consultation with deGhetaldi, it was decided that filling the hole would not create the desired effect and risked worsening the separation of the flake from the rest of the panel. Instead the loss was toned and noted here for potential future treatments. At the time of this treatment the area appeared relatively stable.

Figure 10. Detail of the join between Panels 3 and 4 with fills (on the left) and after being toned (on the right).
